**New International Selection**  
**Full Documentation Fiche 2003**

**composed by national/regional working party of: New Zealand**

current name: Civic Building

former/original/variant name: Auckland City Council Administration Building

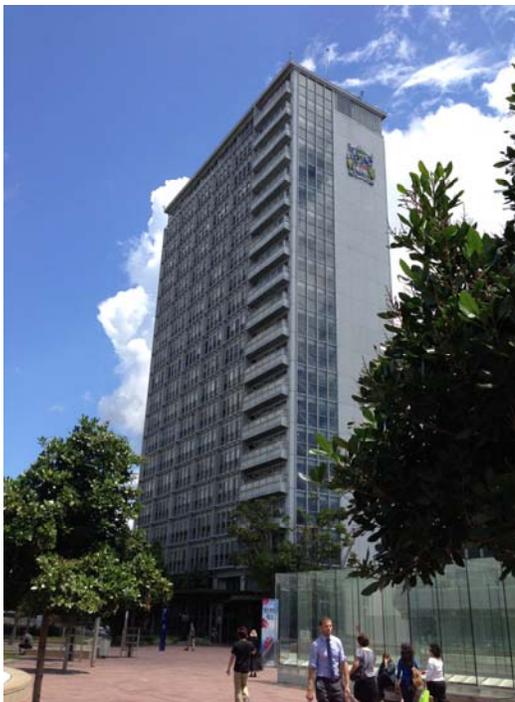
depicted item: Civic Building (also known as the Auckland City Administration Building)  
source: Photograph by Lauren Speer  
date: 20 November 2013

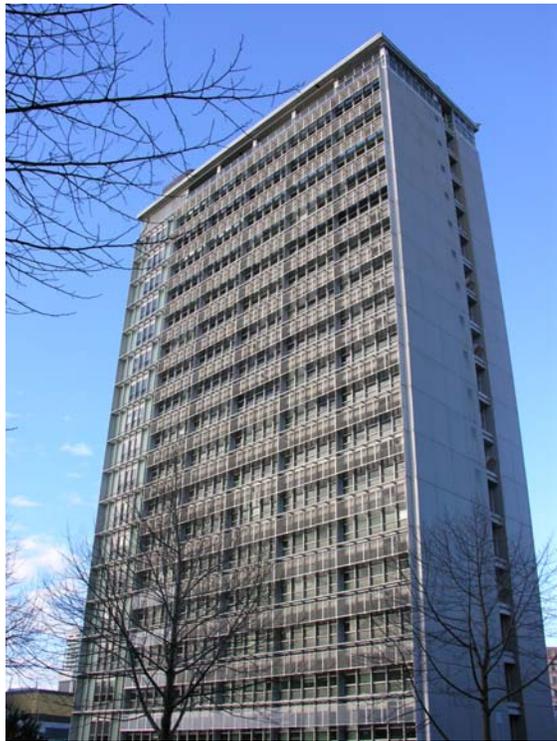
The west elevation. Photograph by Julia Gatley.

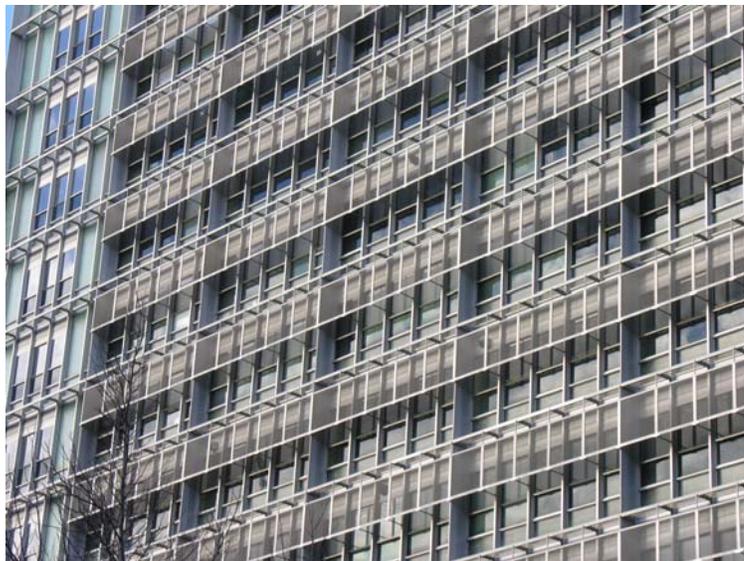
Detail of the glazing on the west elevation. Photograph by Julia Gatley.

The main east façade is modulated by a rhythmic structural system. Five main bays are created, each with four windows. Curtain wall units are used, combining aluminium sunshades, clear panel glass, grey panel solar glass and precast perlite (glass) spandrel panels. The curtain wall module is 4 feet (1.2 metres). The building's north-east corner is further differentiated here, by means of a projecting balcony, in part serving to disguise toilet windows. The top floor is partially recessed and a cornice above effectively crowns or terminates the building. On the west façade, metal sunshading louvres have been used in both the horizontal and vertical directions.<sup>25</sup>
